**SANITARY SEWER COLLECTION SYSTEM
QUARTERLY PROGRESS REPORT
1ST QUARTER – 2021
ONEIDA COUNTY SEWER DISTRICT**

NYSDEC Consent Order R620060823-67

**Sanitary Sewer Collection System
Quarterly Progress Report
1st Quarter - 2021
Oneida County Sewer District
NYSDEC Consent Order R620060823-67**

RDII Analysis

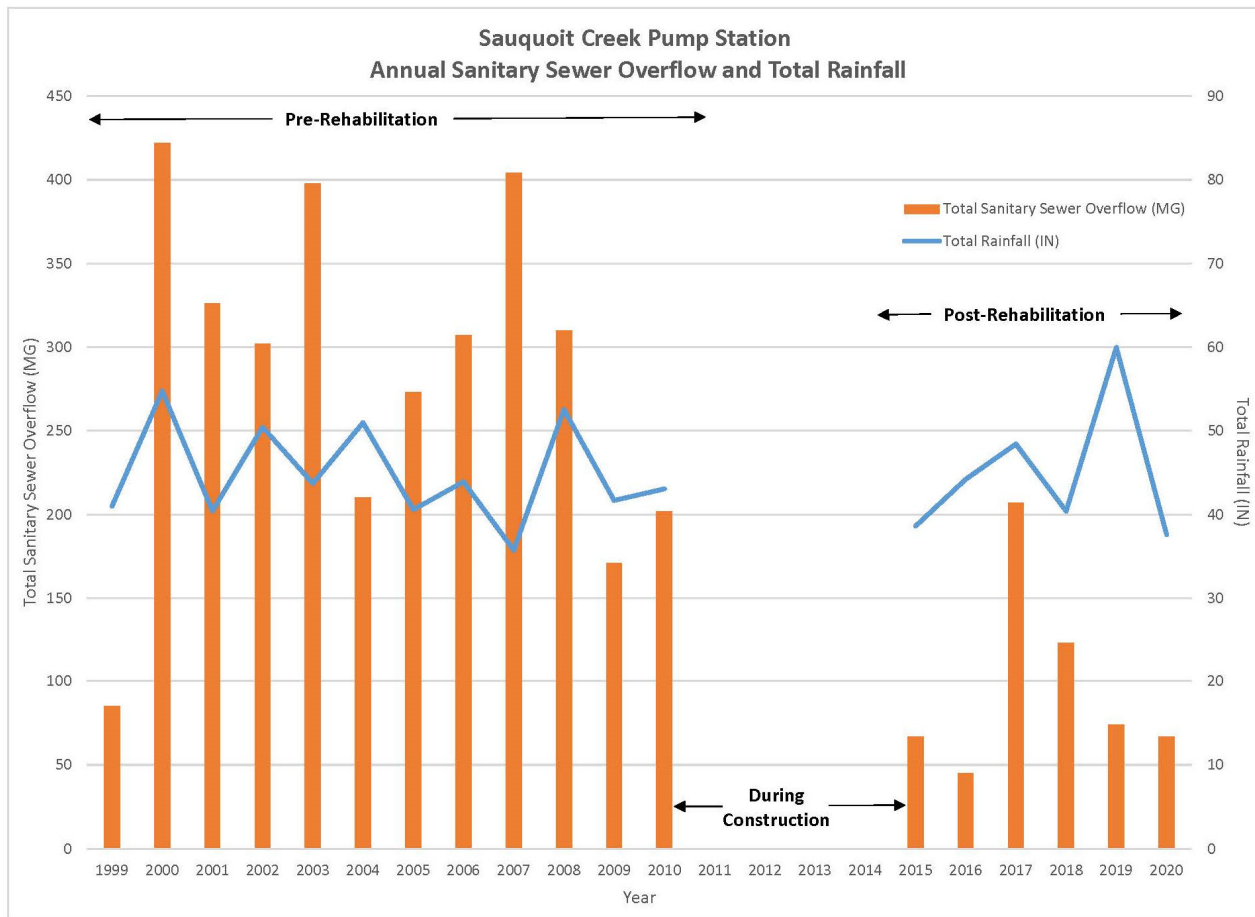
Figure 3.1: Annual Overflow Volume at Sauquoit Creek Pump Station vs. Total Rainfall

In addition to the analysis above, historical rainfall and sanitary sewer overflows at the Sauquoit Creek Pump Station were examined. Figure 3.1 demonstrates the annual total rainfall and the volume of sanitary sewer overflow at the Sauquoit Creek Pump Station from 1999 to 2020. There has been a noted decrease in annual overflow volumes over the period of 2017 to 2020, which is likely attributed to a combination of sewer rehabilitation work performed in the upstream service area and upgrades to the Sauquoit Creek Pump Station resulting in improved service.

Overall, the results of these evaluations indicate that the significant amount of sewer investigation and subsequent rehabilitation work completed to date has had a positive impact on I/I abatement and reducing sanitary sewer overflow volumes at the Sauquoit Creek Pump Station. Additionally, the new 42-inch force main from the Sauquoit Creek Pump Station, scheduled to be put into service in May 2021, was designed to mitigate sanitary sewer overflow volumes since it will allow more flow to be pumped to the WPCP and treated. Although the overflow volumes at the Sauquoit Creek Pump Station have been significantly reduced, there still appears to be I/I entering the sewer system in a few select areas of the system. Rehabilitation work to date has consisted of cured-in-place-pipe (CIPP) lining, lateral joint grouting, pipe joint grouting, and manhole rehabilitation. These methods have the potential to eliminate infiltration and repair the structural integrity of the sewer main, but are limited to addressing mostly public side I/I sources. Further investigation is warranted to identify and address other sources of I/I, such as cross connections between storm and sanitary sewers and private side I/I (see Section 3.3). Based on the high I/I observed in certain areas of the collection system, additional sewer investigation is planned for areas of noted concern as indicated in Section 2.1.4. Continued sewer investigation and rehabilitation work is important to further I/I abatement, as well as help build excess capacity in the collection system for future growth. The combination of past and future sewer rehabilitation work and the new 42-inch force main from the Sauquoit Creek Pump Station are intended to mitigate the overflow at the SCPS according to the Consent Order.

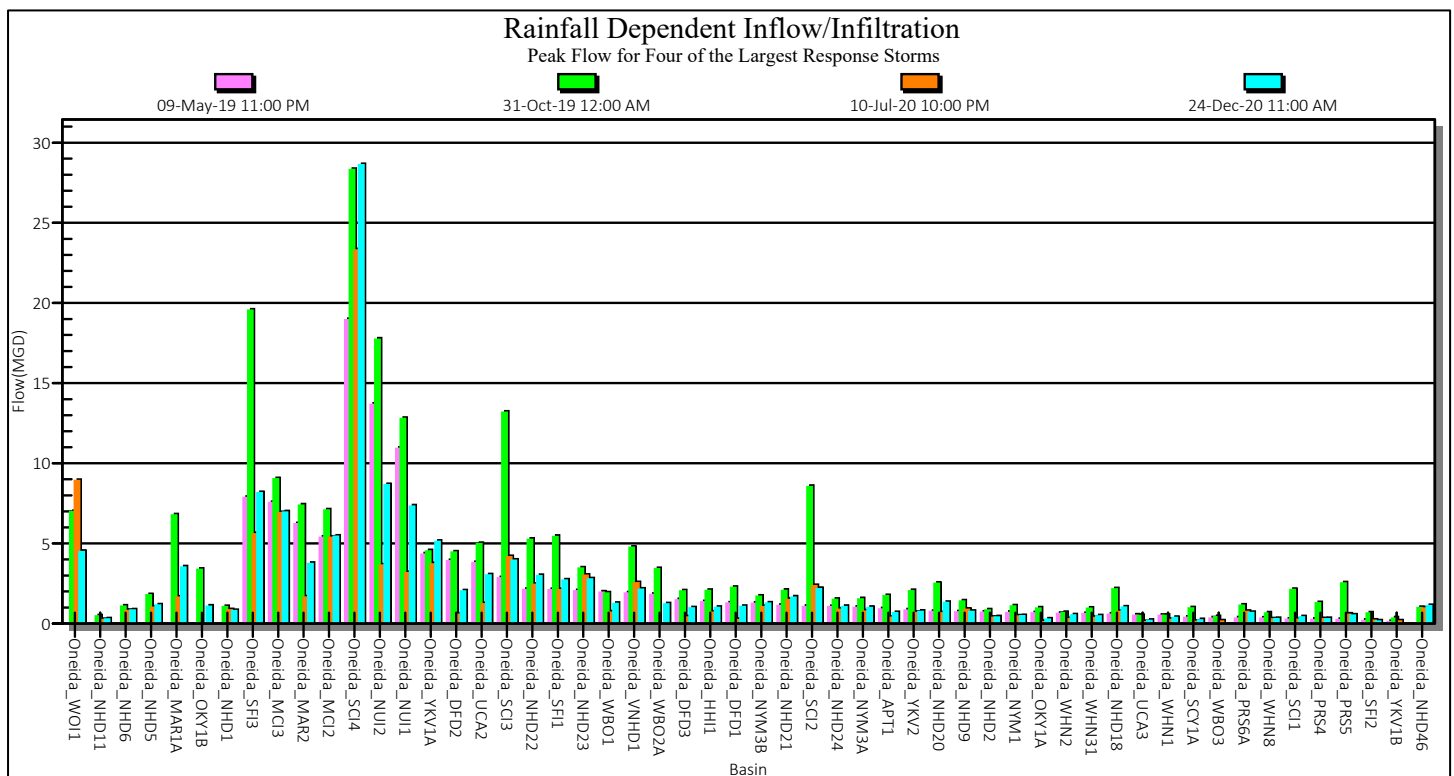
Figure 2 Peak flows for 4 largest peak flow events including Christmas 2020.

The Christmas 2020 storm resulted in some of the greatest peak flows during the metering period at many of the sites. almost all the meter sites in the network. Figure 2 is a bar graph of the peak 1-hour flow rate for four of the largest responding storms during the metering period. It was the largest flow response at SCI4. The Christmas storm was approximately 1.5 inches system-wide, but it was preceded by approximately 0.5 inches the prior 2 days. Hydrographs for this period for all sites are included in Appendix A.

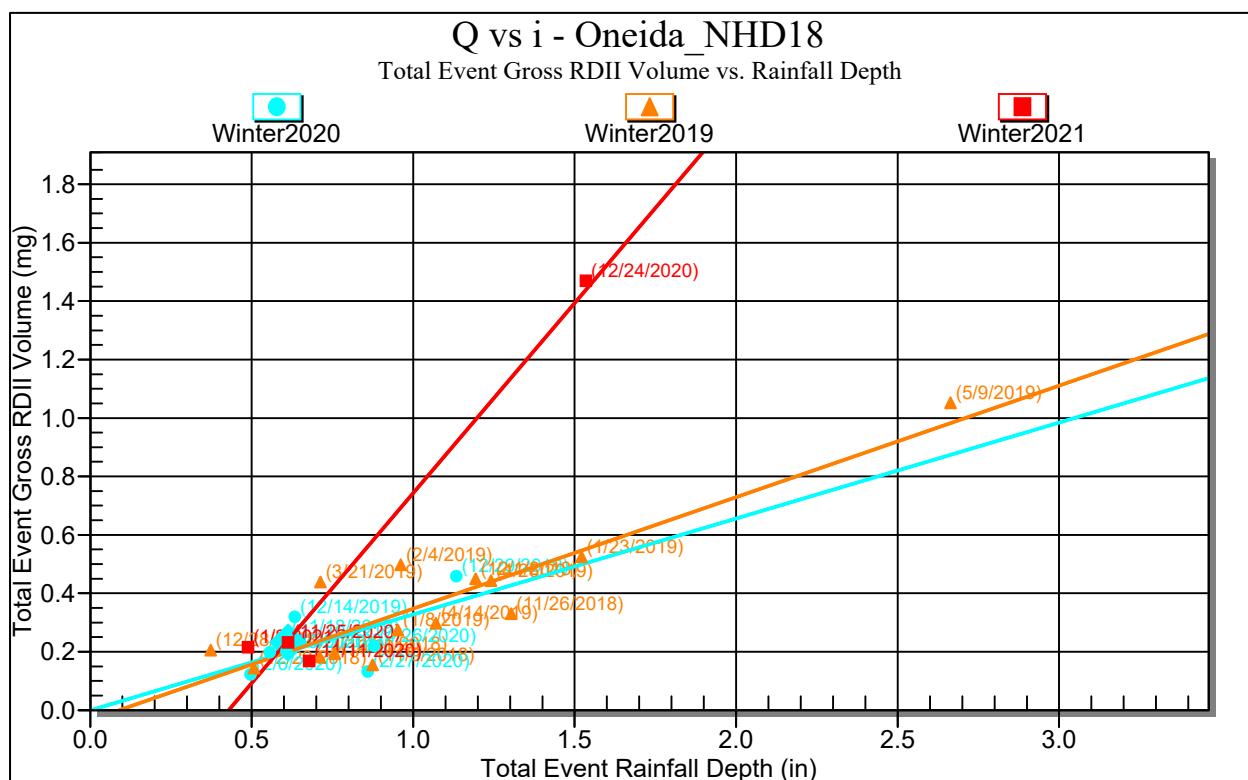
Figure 3 Q vs i plot example showing Christmas storm.

Figure 3 is a Q vs i plot for NHD18 and this behavior is typical for the entire system. The Christmas storm that began on 24 December is an outlier when compared to all other winter storms. Storms that include a snow melt appear this way on a Q vs i plot; the RDII volume is unusually high for the measured rainfall. But the weather records don't indicate that there was snow on the ground in December. If snow melt has a part to play in a winter storm, that storm normally is removed from these plots. This storm is left in for all the plots in Appendix A. There are storms through early May 2021 that will eventually be included in the winter 2021 set of storms.

The most notable wet weather event throughout the 2020 flow metering data collection period was on December 24, 2020 and was called the Christmas 2020 event within the ADS report. The Christmas 2020 event consisted of approximately 1.5 inches of precipitation (system wide average). It should be noted that the two preceding days leading up to the event totaled 0.5 inches of rainfall and ADS stated that there was no snow on the ground prior to the event, indicating snowmelt was not a factor. To quantify this event further, Table 3 in the ADS Report (Appendix B) indicates the return period frequency of each rain event at all rain gauges, which shows that while several storms throughout 2020 exceeded a 1-year return period frequency, the Christmas 2020 event return period frequency was less than 6-months (at all rain gauges). The return frequency for this event was relatively low in comparison to the high RDII volume observed, indicating this event could likely be considered atypical. This event was not excluded from the winter season Q vs I comparison graphs (included in Appendix C) because snowmelt was not a factor. However, antecedent conditions caused inflow measured at all locations to be significantly higher than normal years. Therefore, this event is considered an outlier that impacted the 2020 flow monitoring analysis results.

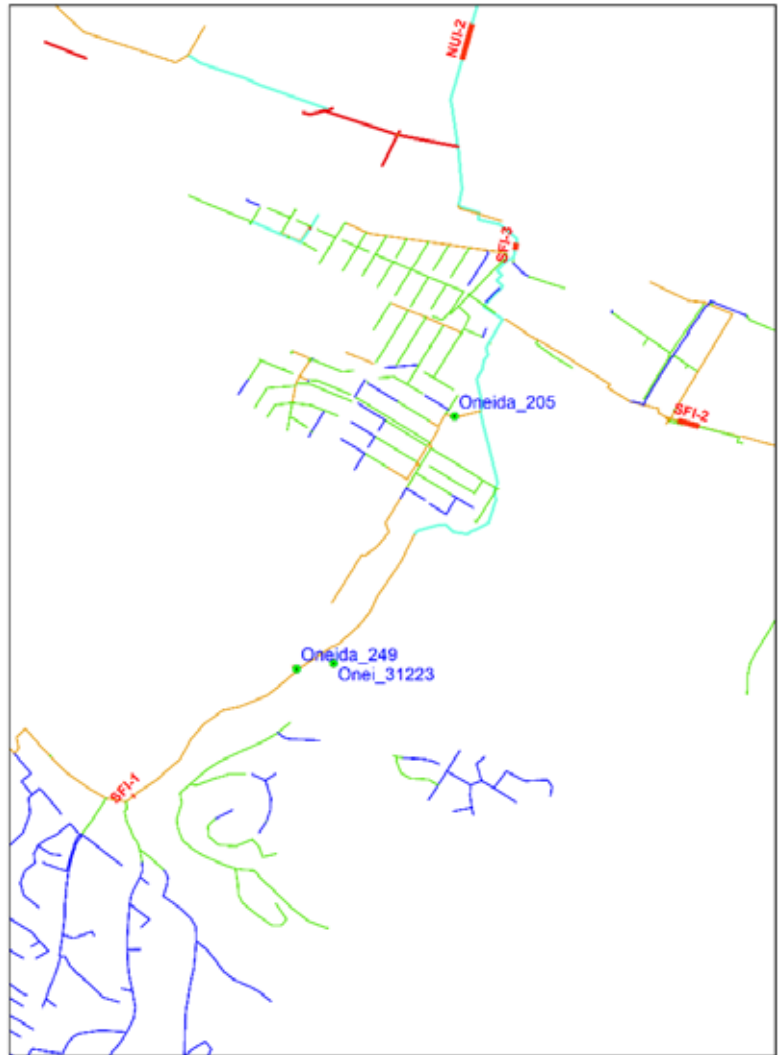
Figure 4 Map of the six meters in Starch Factory sewershed.

The very large 19.5 mgd peak hourly flow at SFI3 during the Halloween storm prompted the County to add three temporary meters in the Starch Factory sewershed in January 2020. The three meters are on side branches as shown in Figure 4. The actual GIS sewer lines are missing for Oneida_249 and Oneida_31223 meters.

The sewershed above meter Oneida_205 is continues to produce the greatest RDII volumes.

Starch Factory Interceptor (outside of the SCPS Basin) in December 2019. The purpose of these meters was to isolate portions of the Starch Factory Interceptor basin so that areas of excess infiltration and inflow (I/I) could be identified. The data collected by these flowmeters is currently being analyzed. That said, preliminary results provided in the report by ADS indicate that the sewershed tributary to meter “Oneida_205” located within Proctor Park, appears to be contributing the most Rain Derived I/I (RDII) in the Starch Factory Interceptor area.

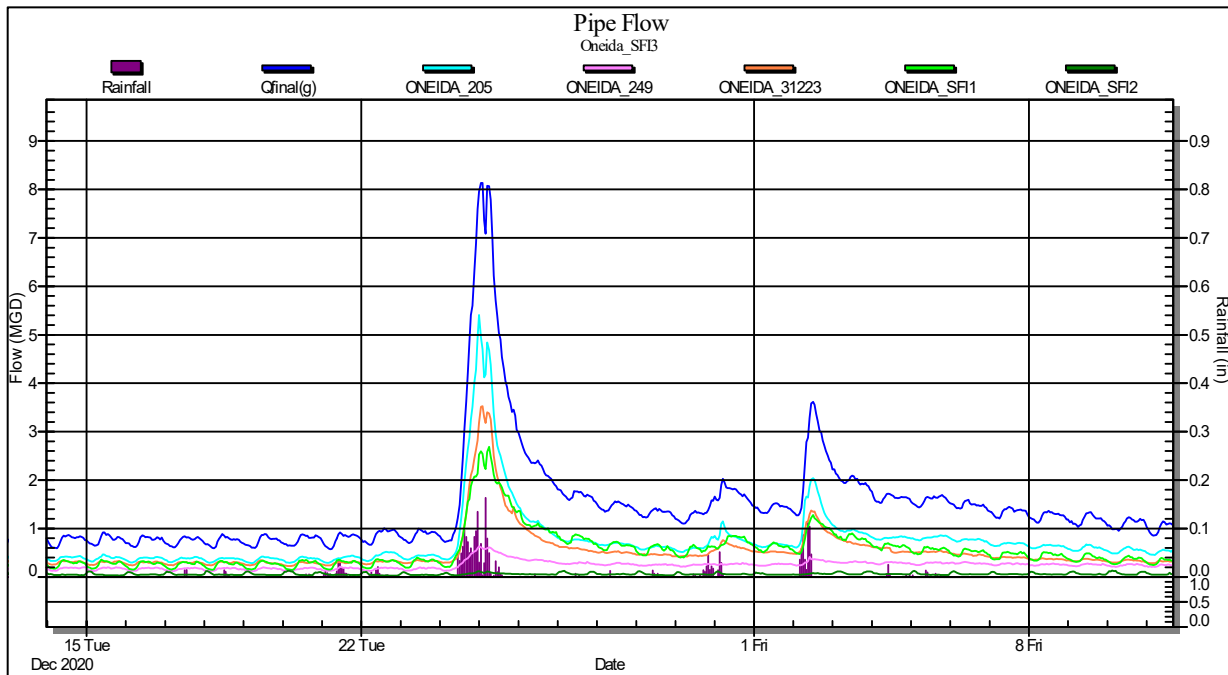
Figure 5 Hydrographs of the six Starch Factory meters for the Christmas storm.

Figure 5 shows a hydrograph from the Starch Factory sewershed around the Christmas storm. Basin Oneida_205 appears to be contributing the most RDII.

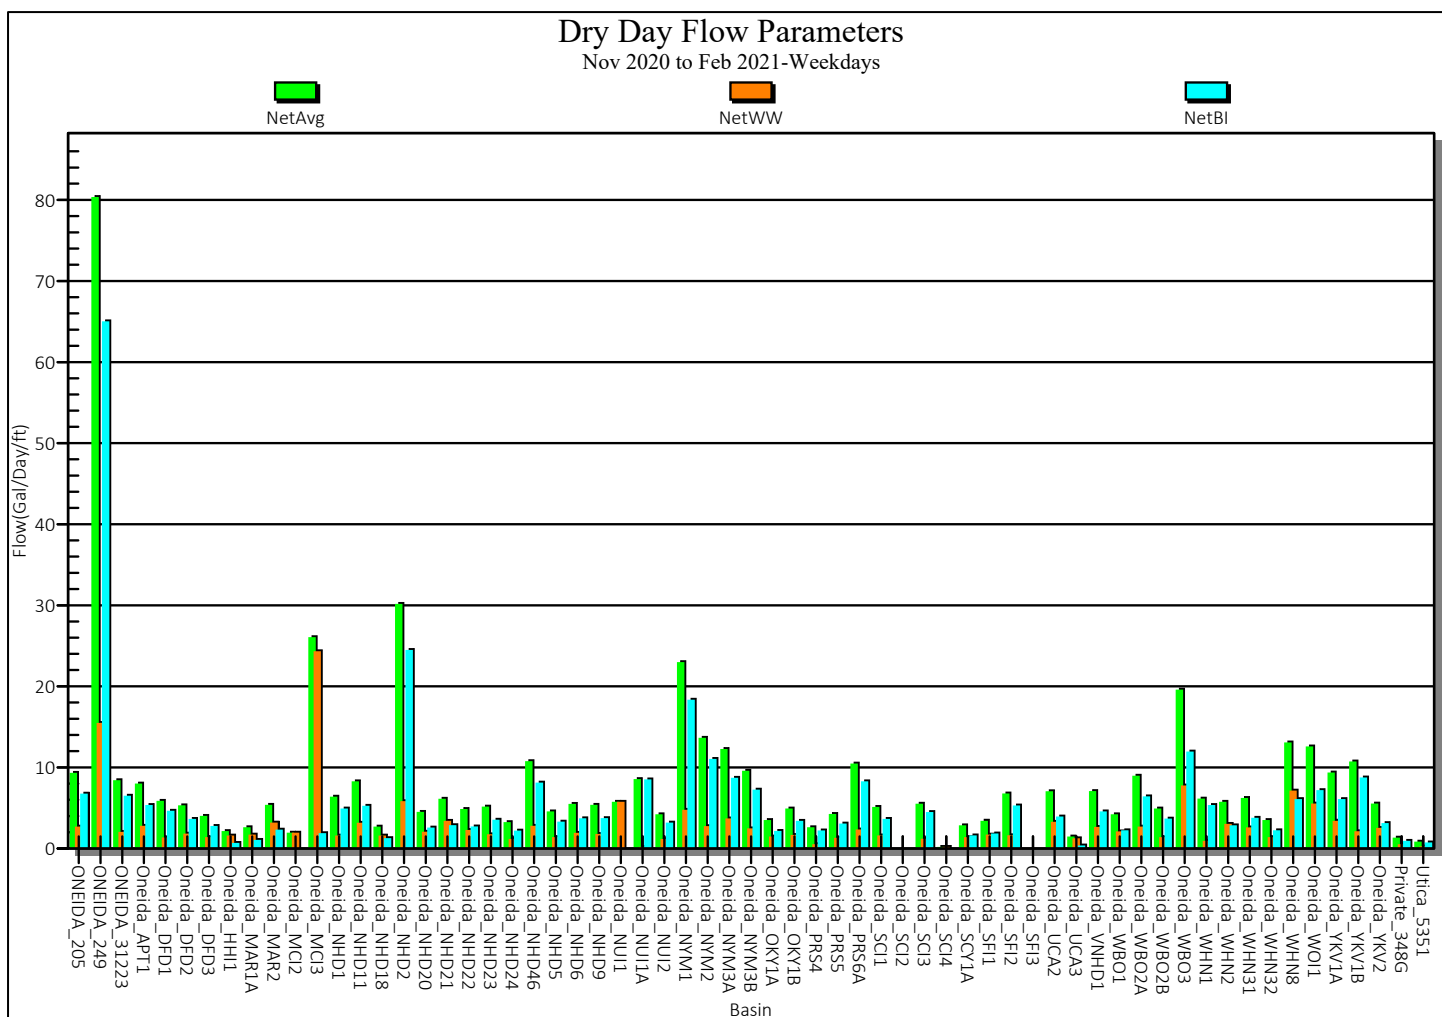
Figure 6 Base Infiltration for Summer and Winter periods. Values above the red line have BI values of greater than 50% of the flow.

Figure 6 shows the Average Dry Day Flow (NetAvg), Wastewater Production (NetWW) and Base Infiltration (NetBI) values for the winter of 2020, which include data from November 2020 through February 2021. These values are normalized by the length of sewer in each basin and the values are in GPD/LF. The wastewater production value of 5 GPD/LF is the upper limit of wastewater production that we would expect from residential areas. Low density housing can as low at 1 GPD/LF. Many of these sites exhibit base infiltration values higher than the wastewater. The very high value for Oneida_249 appears to be due to private sewer that are not included in the basin size tally.

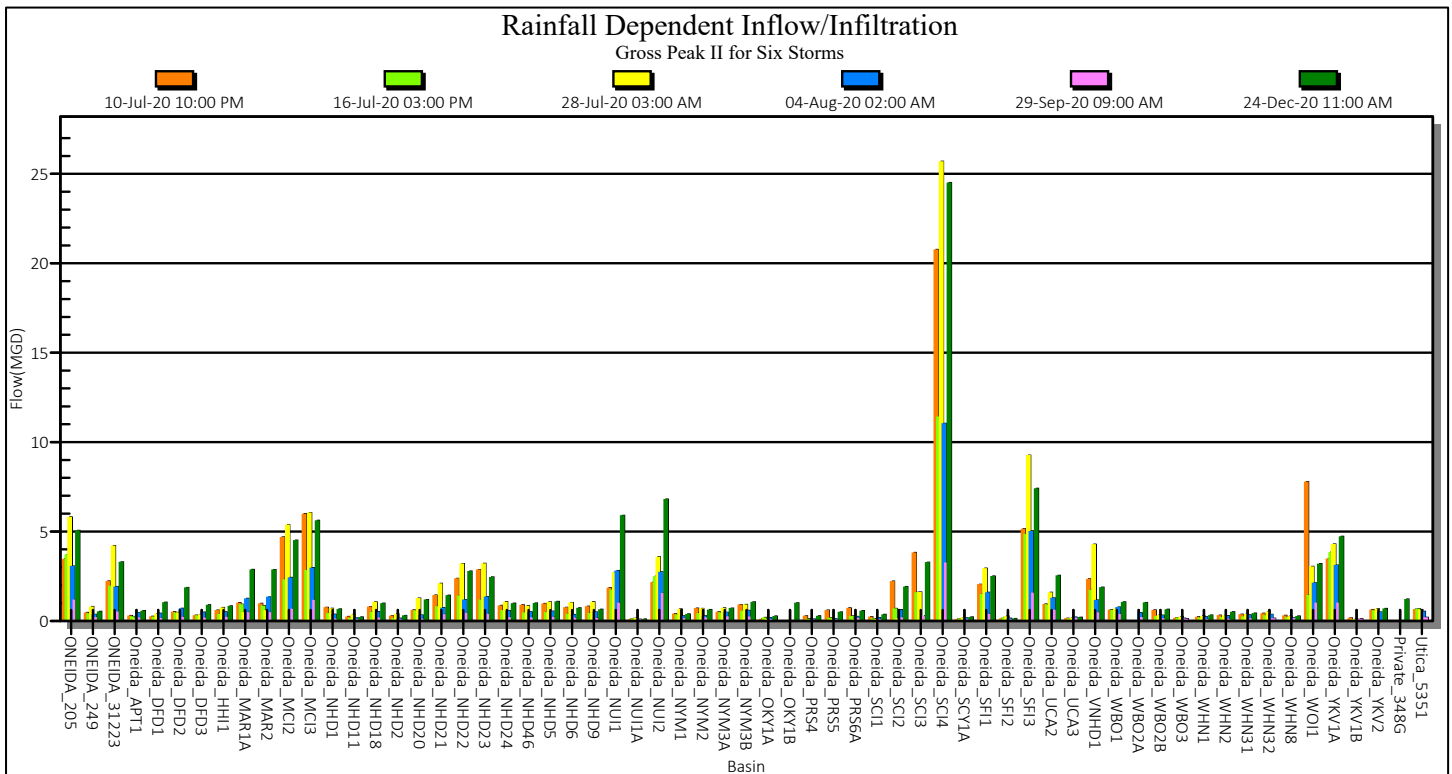
Figure 7 Peak flows recorded at each meter for the 6 largest storms during the study period.

Figure 7 shows the Gross Peak flow rate for the 6 largest storms. This is the peak flow rate recorded by each meter.

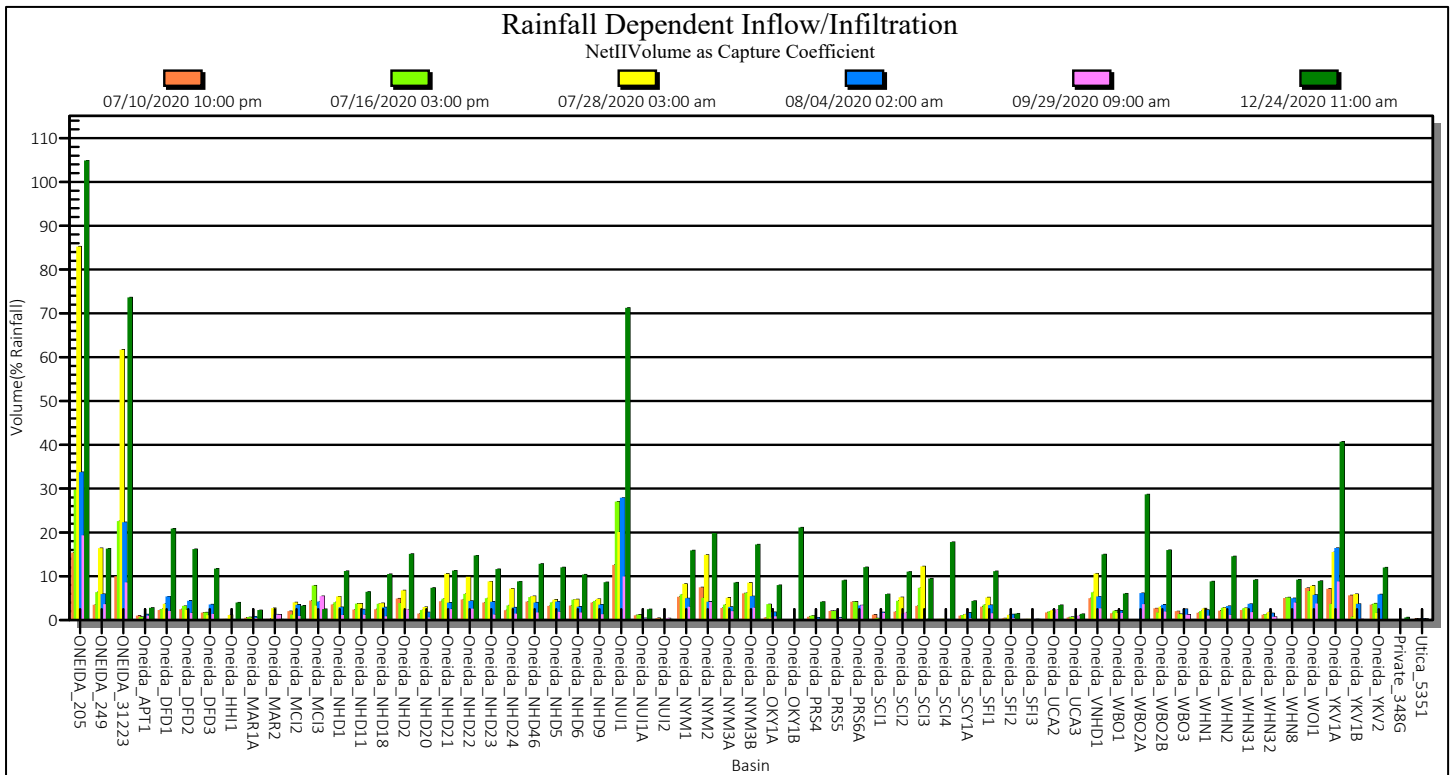
Figure 9 Capture Coefficient for 6 largest response storms.

Figure 9 lists the Capture Coefficient or the percent of the rainfall entering the sewer as RDII for each sewershed. A general rule of thumb is that values greater than 5% fall into the marginal category and values greater that 7% to 10% fall into the severe category.

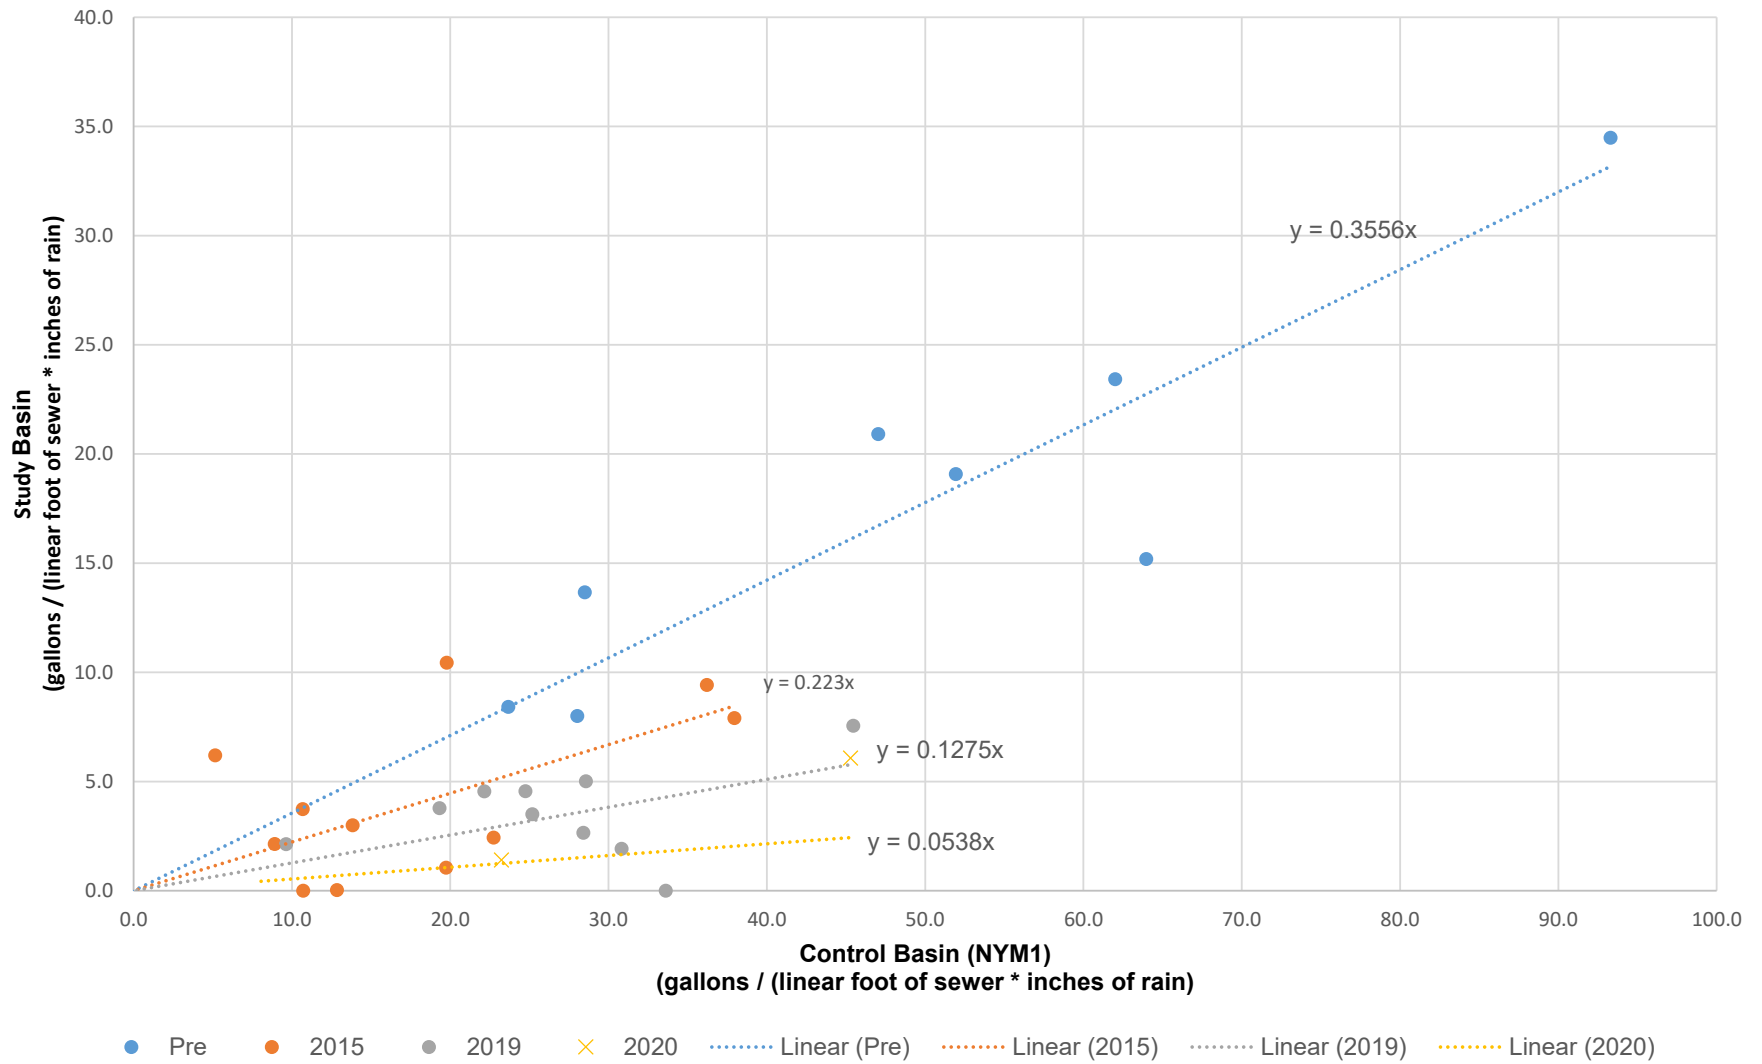
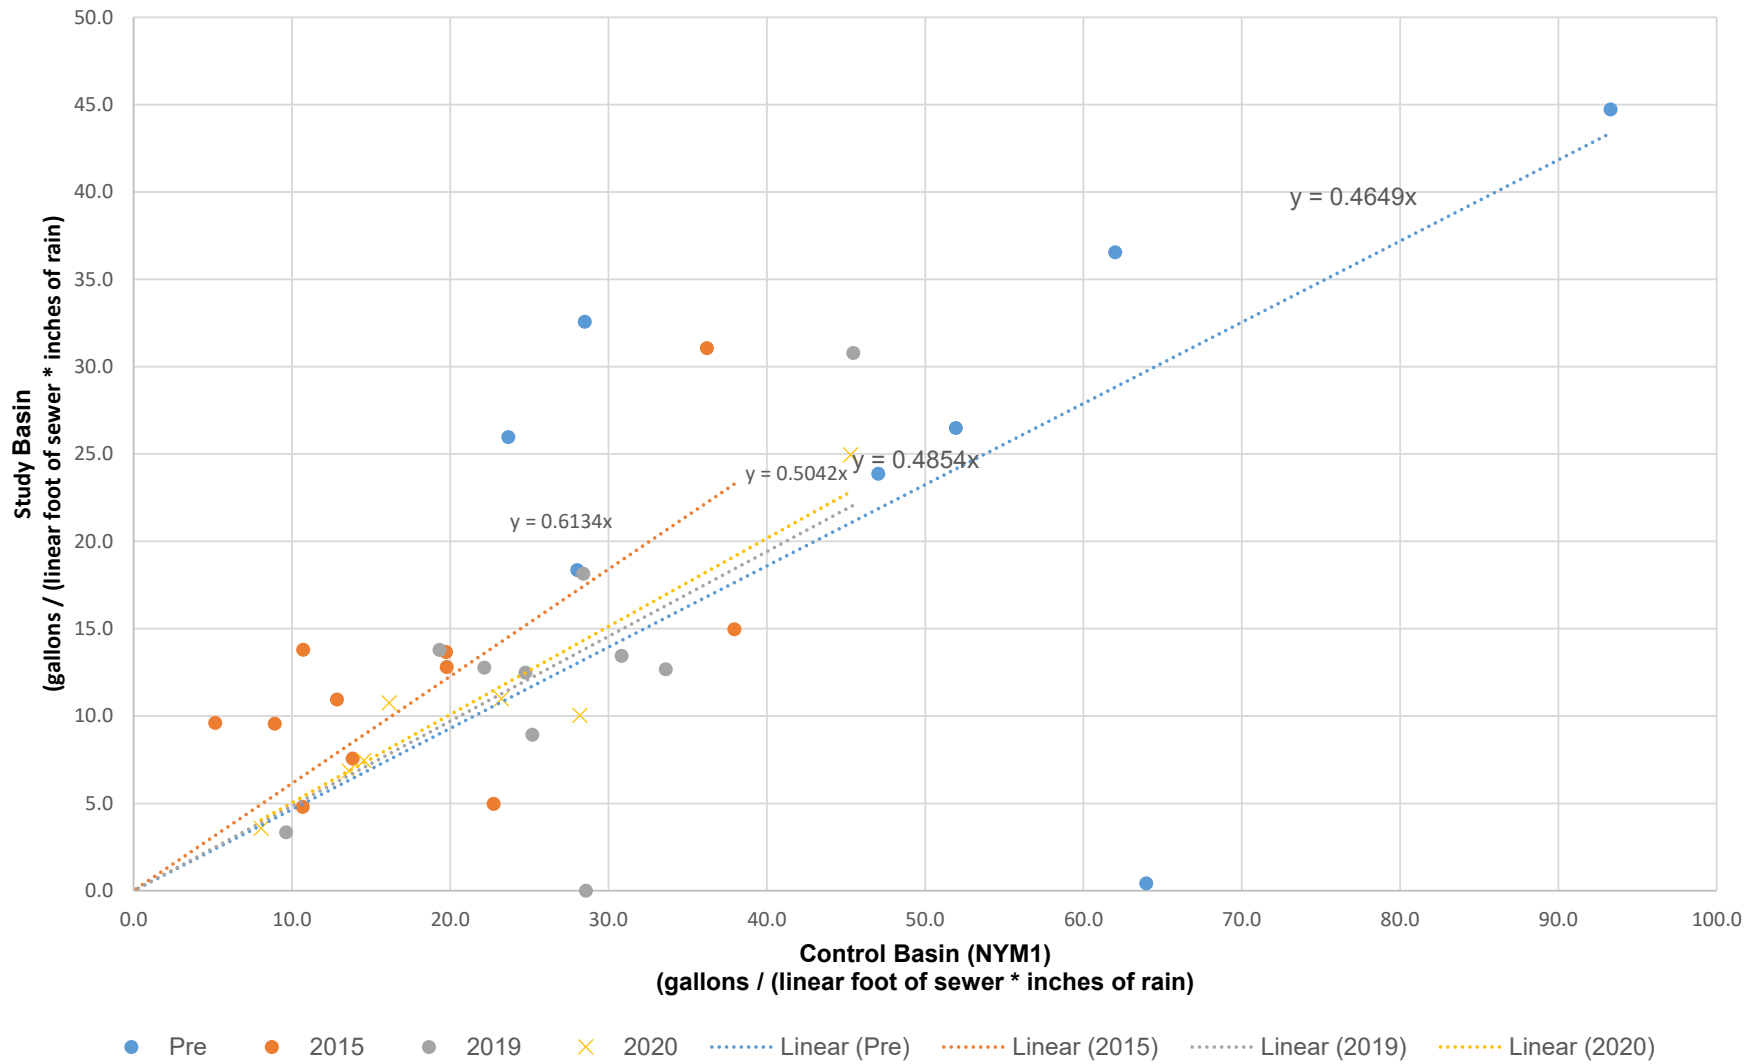
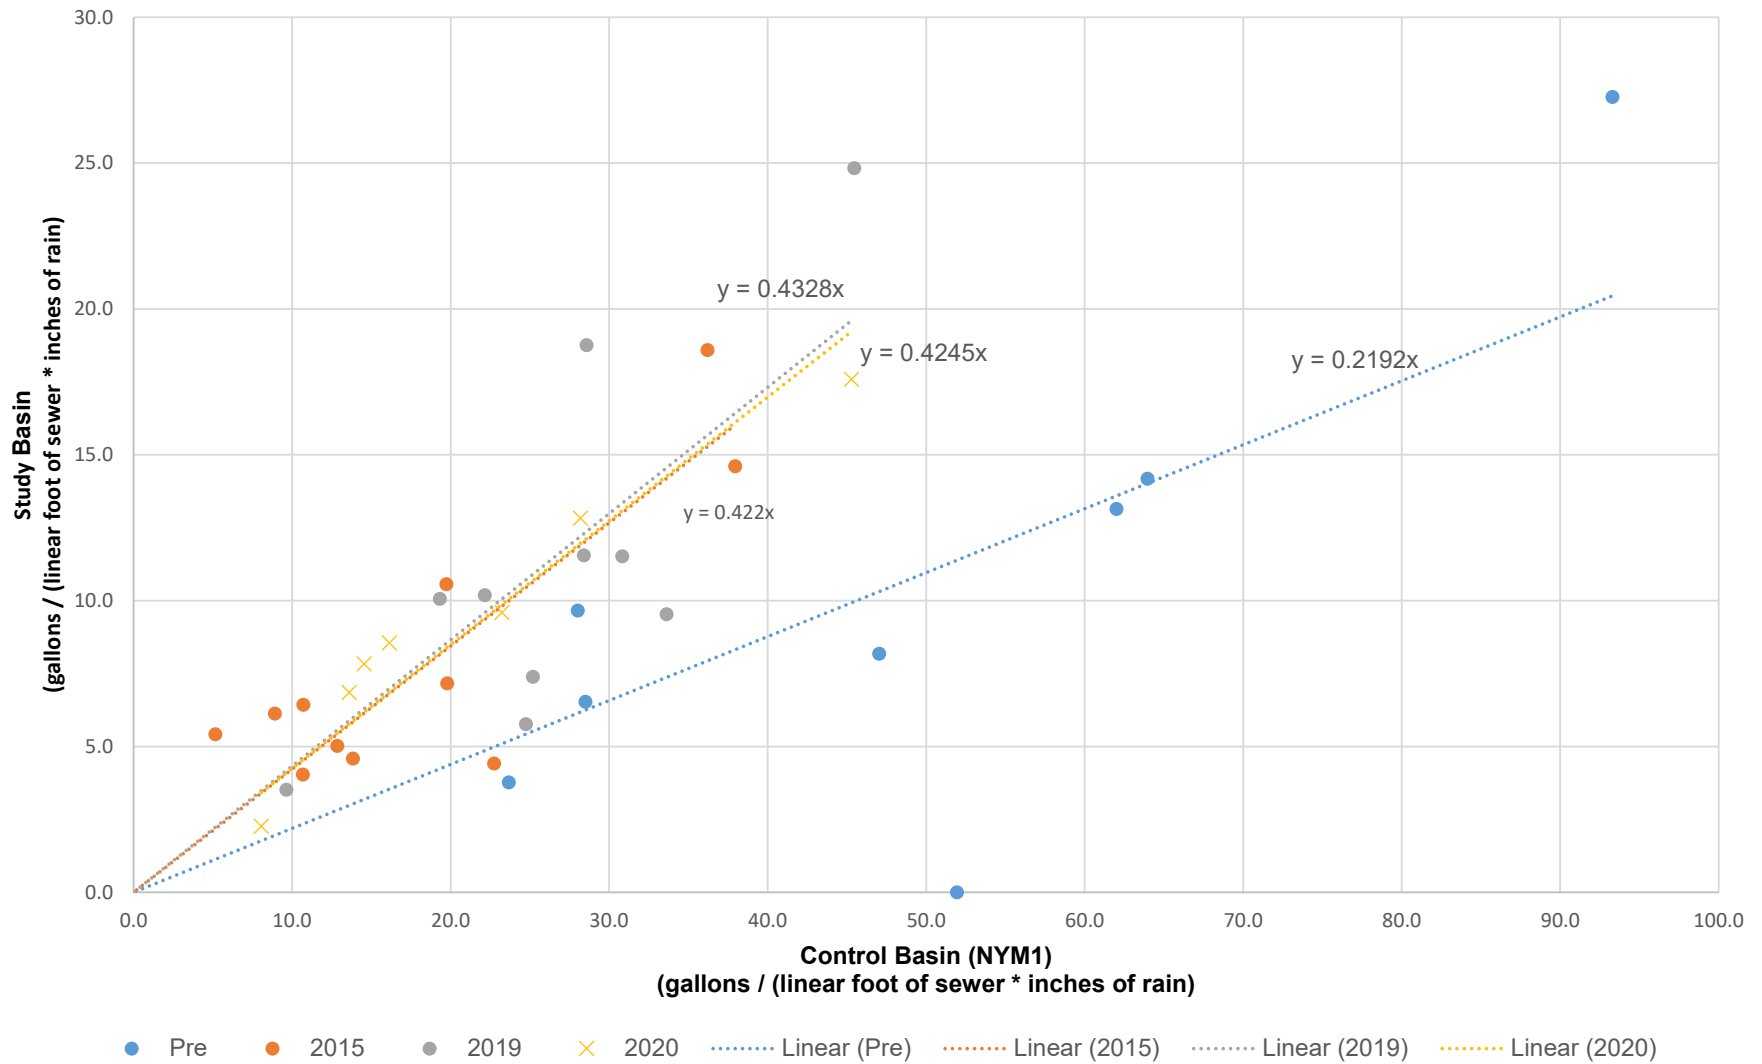
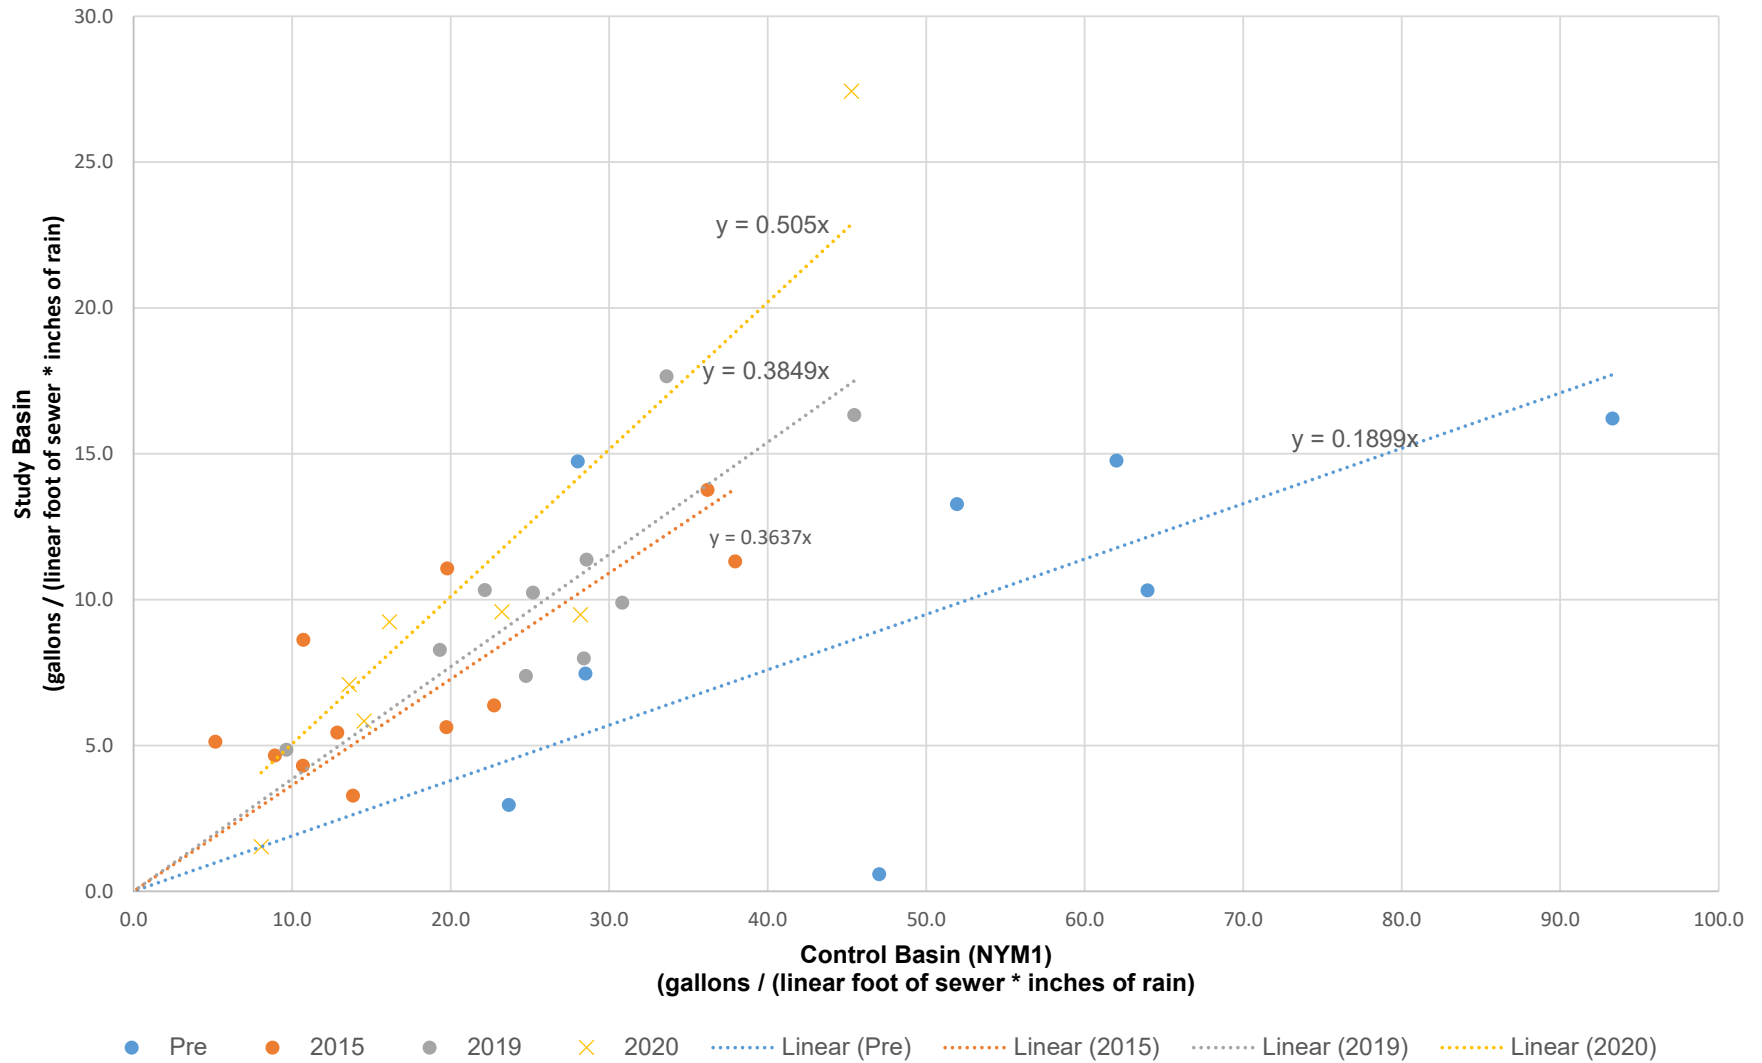
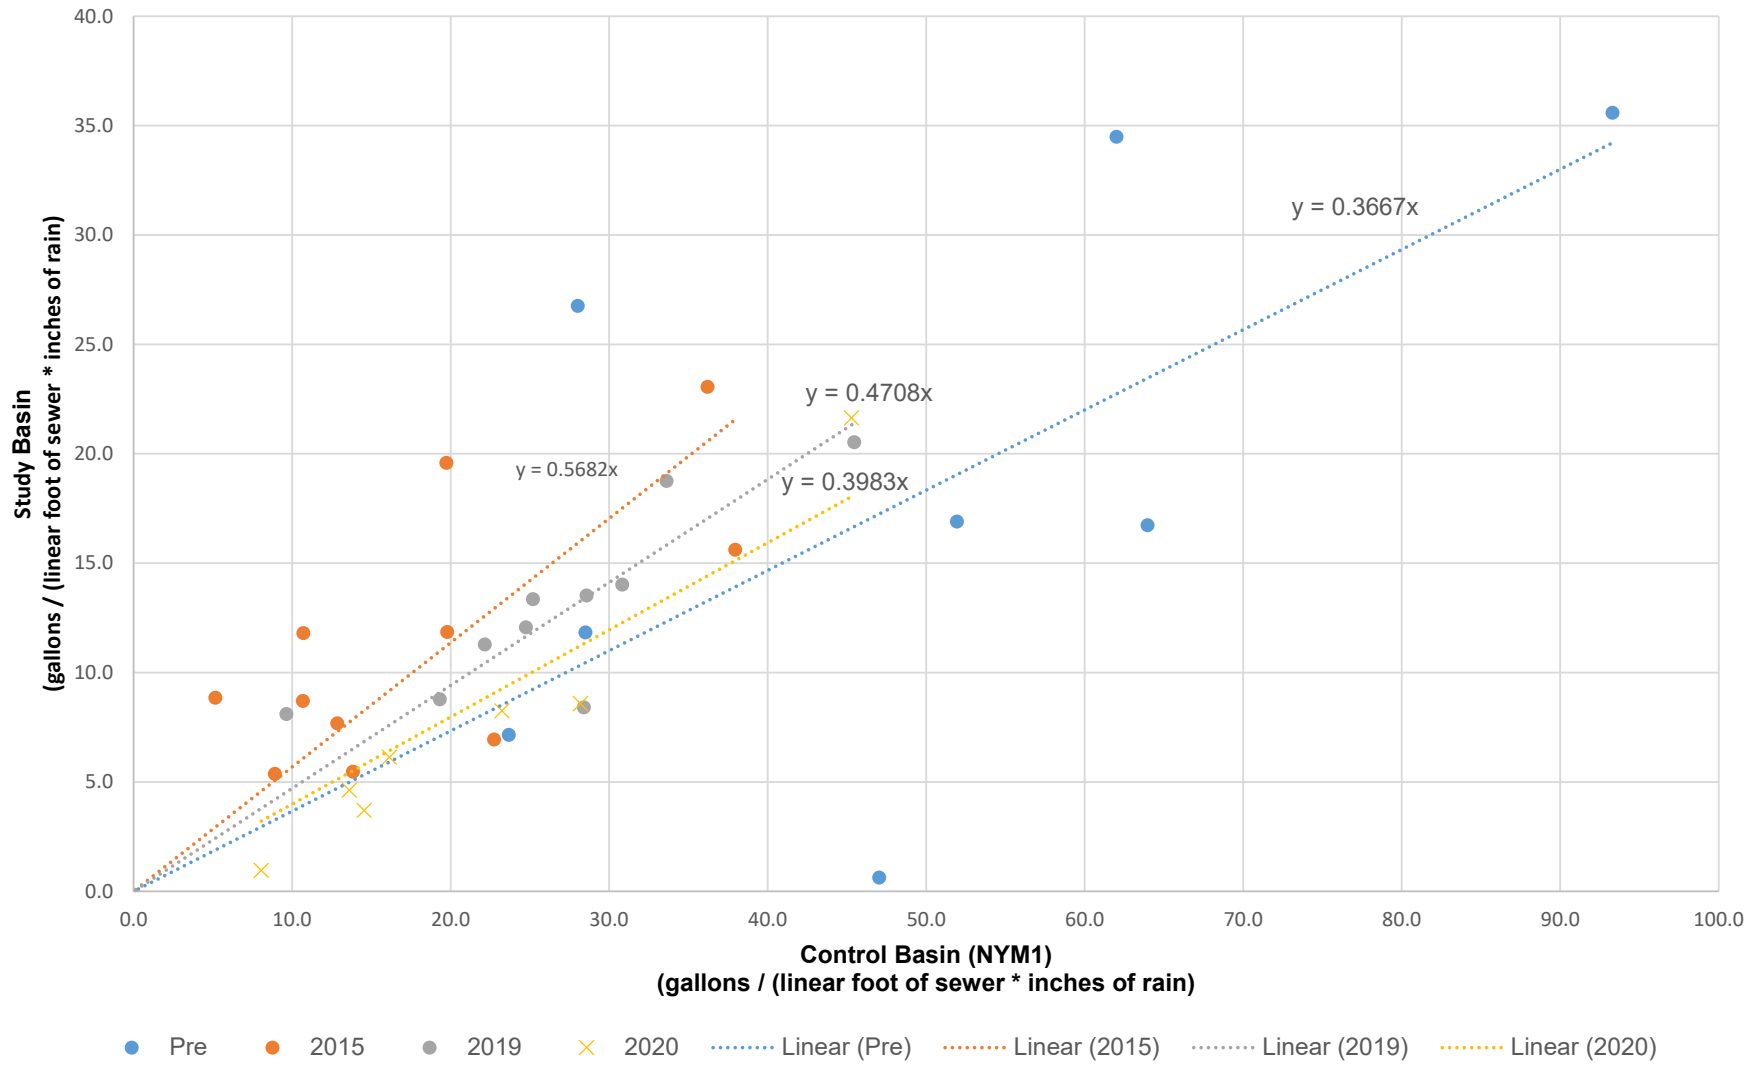
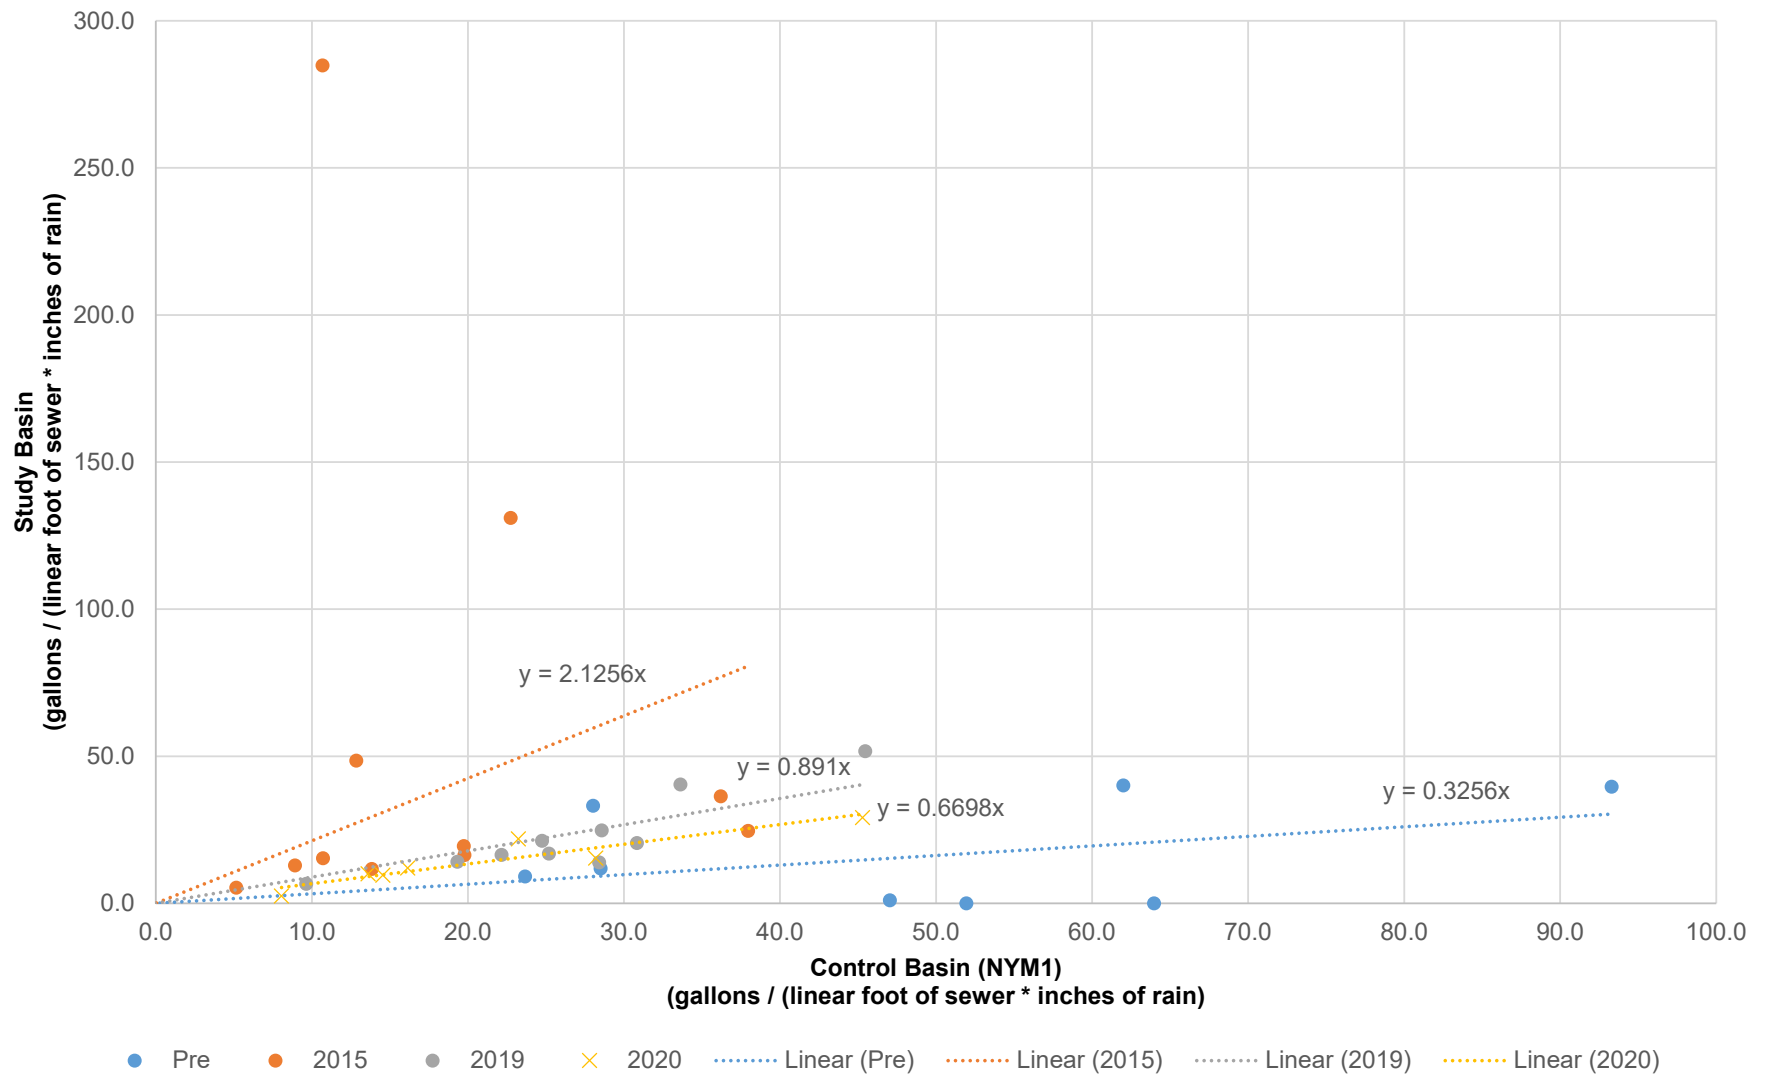
The normalized RDII charts showed increased RDII in both 2019 and 2020 compared to 2008 for flowmeters NHD6, NHD9, NHD18, NHD20, NHD23, PRS5, SCI1, and YKV1A. Flowmeter HHI1 showed lower RDII in both 2019 and 2020, while flowmeters WHN2 and PRS4 showed higher in 2019 but lower in 2020. In addition to the previous areas analyzed, data for two additional flowmeters (YKV1B and YKV2) were examined as County personnel indicated that this part of the system has demonstrated operational issues during wet weather. These two flowmeters were not part of the original flow monitoring effort in 2008, but an increase was observed when comparing 2015 to 2019 and 2020 data for YKV2, while YKV1B showed an increase from 2015 to 2019 but a decrease in 2020.
